SEDIMENT BARRIER - HAY BALES

NORTHEAST RELIABILITY INTERCONNECT PROJECT

FIGURE 21 SEDIMENT BARRIER HAY BALES

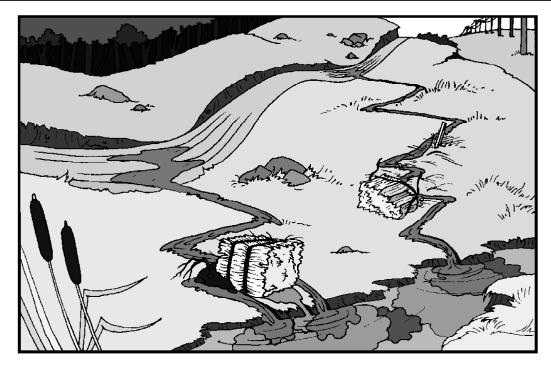
IMPROPER INSTALLATION

- Hay bales are not staked
- ullet Not enough hay bales to adequately capture and slow flow
 - •Too far from source of runoff and sediment
- Improper orientation of bales: horizontal grass fibers do not provide adequate filtration
 - Baling twine in contact with ground

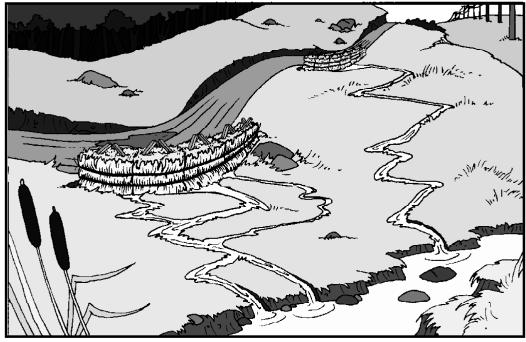
PROPER INSTALLATION

- Staked properly; bales are secure and snug to one another
- ullet Sufficient number of bales to slow flow and insure that no water escapes around edges
 - Positioned close to disturbance, and far from resource to allow proper filtration
 - ____ Vertical orientation of grass fibers provides adequate filtration
 - •Baling twine does not contact ground
